Former Fishing Co-operative Building 11 Ocean Road South, Lorne

Adaptive Reuse Feasibility Report

August 2023

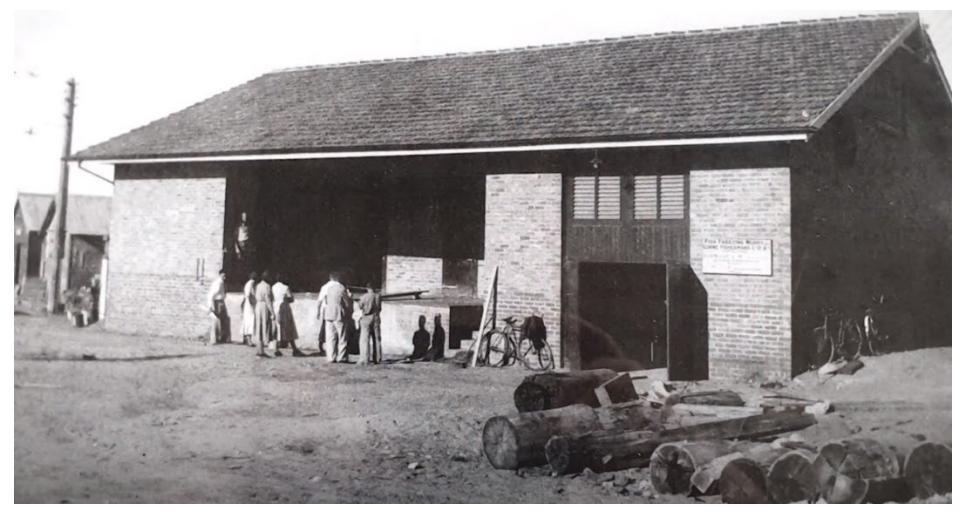
• Remove the unsympathetic paint from the façade. Historic photographs suggest a two-tone brick construction which should be retained.

The original building during construction, with darker brick to the lower section (1948)

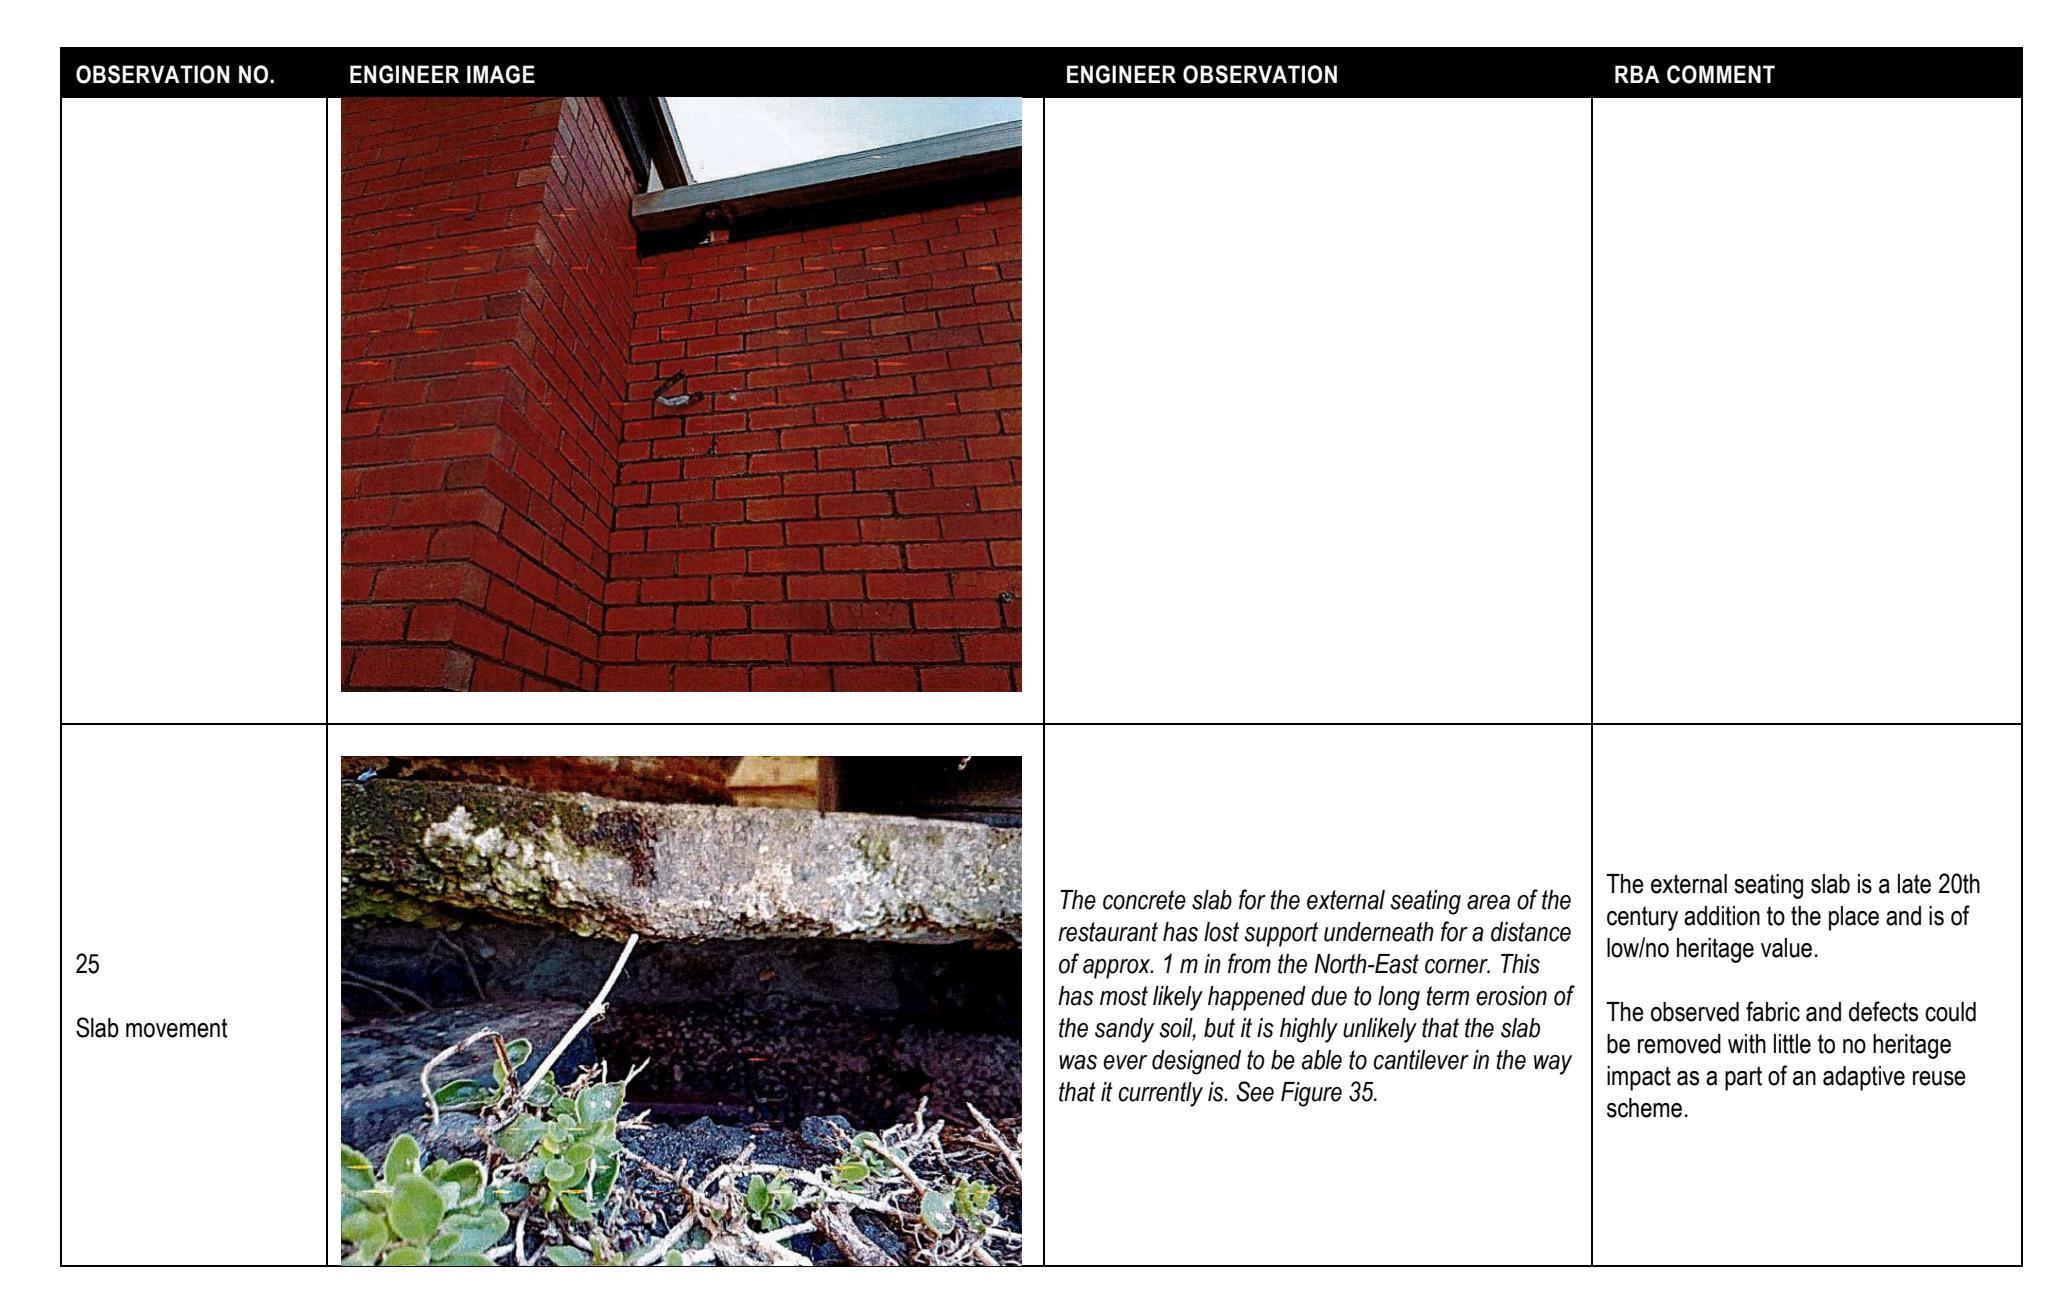
OBSERVATION NO.	ENGINEER IMAGE	ENGINEER OBSERVATION	RBA COMMENT
24 External cracking above windows Missing downpipe	<image/>	An 8-10mm crack runs horizontally along the top of the two rear windows, indicating a degree of slab movement towards the South most corner of the building. This movement is most likely caused due to long term wetting of the underlying sand soil, thus causing a lack of strength and a drop in the slab. It is observed that the downpipe in the South corner of the building has been removed or broken off and any water caught on the roof has freely pooled against the foundations in this area. This has clearly been a long term issue as there is significant moss growth up the brickwork and the ground is visibly saturated. See Figures 32-34.	Further investigation required by experienced heritage structural engineer. Conservation should be undertaken as a part of an adaptive reuse scheme for the site. Area with downpipe is part of a later addition at the site and is of lower heritage value. The fabric could be removed with little to no heritage impact as a part of an adaptive reuse scheme
